# Manhole Inspection Summary

Manhole # S51GG\_012MH

Insp Date: **6/9/08 8:19 AM**

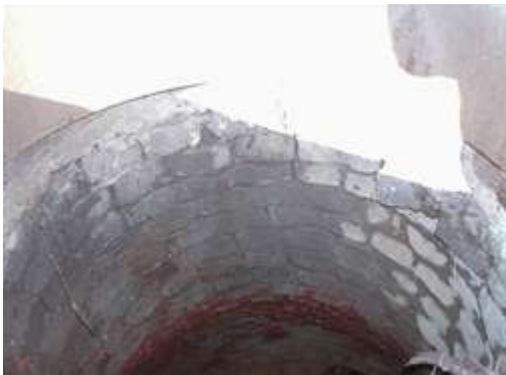
Defect 1

Infiltration: ☐ None ☒ **Joint** ☐ Cracks ☒ **Mortar** ☐ Roots ☐ Wall

Infiltration: ☐ None ☐ Joint ☐ Cracks ☐ Mortar ☐ Roots ☒ **Wall**

infiltration

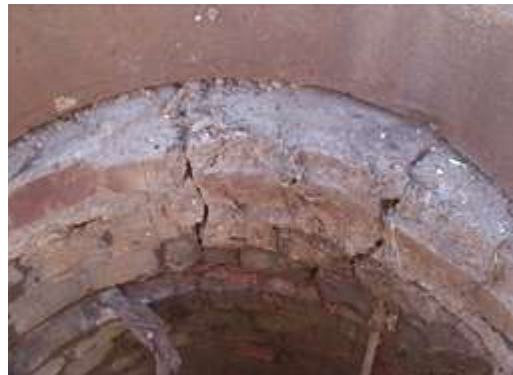
Defect 2

Condition: ☐ Sound ☐ Cracked ☐ Root Intrusion ☒ **Loose Brick** ☐ Deteriorated

loose bricks,

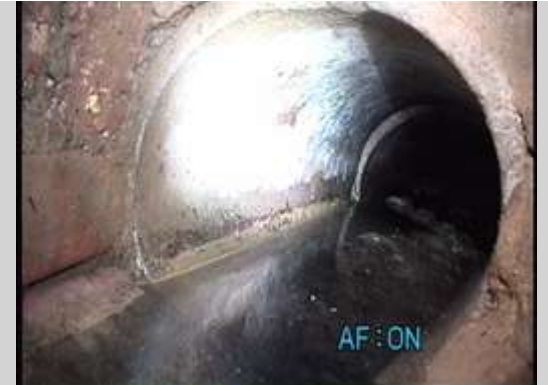
12 O'Clock Outflow

8 in. Circular Gravity Sewer  
Pipe Out @ 12 O'Clock

Pipe Height: **8.4** (in.) Rod and Bar (Angled)  
Pipe Material: **Clay** ☐ Pipe Lined  
Invert Depth: **7.60** (ft.) Flow Characteristics: **Slow**  
Deposits: ☒ None ☐ Mud ☐ Sludge ☐ Debris ☐ Grease  
Silt Depth: (in.) Deposits Extent:  
Infiltration: **None** Pipe Seal Cond: **Sound**

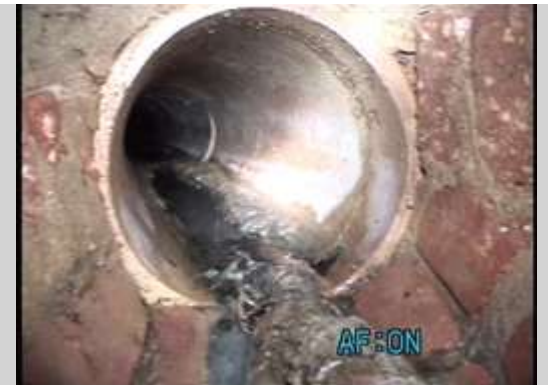
3 O'Clock Inflow

8 in. Circular Gravity Sewer  
Pipe In @ 3 O'Clock

Pipe Height: **8.4** (in.) Rod and Bar (Angled)  
Pipe Material: **Clay** ☐ Pipe Lined  
Invert Depth: **7.10** (ft.) Flow Characteristics: **Slow**  
Deposits: ☒ None ☐ Mud ☐ Sludge ☐ Debris ☐ Grease  
Silt Depth: (in.) Deposits Extent:  
Infiltration: **None** Pipe Seal Cond: **Sound**
